# TOYOTA

SUBJECT: SPECIAL SERVICE CAMPAIGN – S02  
(1993 and 1994 LAND CRUISER O<sub>2</sub> SENSOR)

## **SSC S02 – TOYOTA LAND CRUISER OXYGEN SENSOR SPECIAL SERVICE CAMPAIGN NOTICE**

**TECHNICAL INSTRUCTIONS**  
**FOR**  
**SPECIAL SERVICE CAMPAIGN S02**

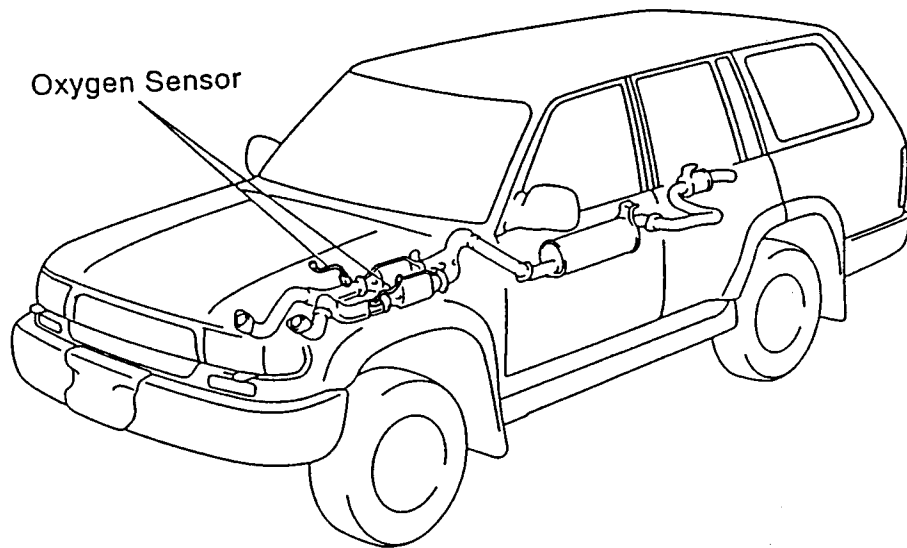
### **III. LOCATION OF AFFECTED PARTS**

Toyota has determined that the oxygen sensor heater wire on the vehicle may have an open circuit due to repeated thermal stress, causing the Malfunction Indicator Lamp (MIL) to illuminate.

**Toyota will initiate a Special Service Campaign to replace the O<sub>2</sub> sensors on 1993 and 1994 model year Toyota Land Cruisers.**
