SECTION 319 NONPOINT SOURCE POLLUTION CONTROL PROGRAM

WATERSHED PROJECT FINAL REPORT

**Lefthand OHV Area Restoration Project
Phase II**

October 18, 2011

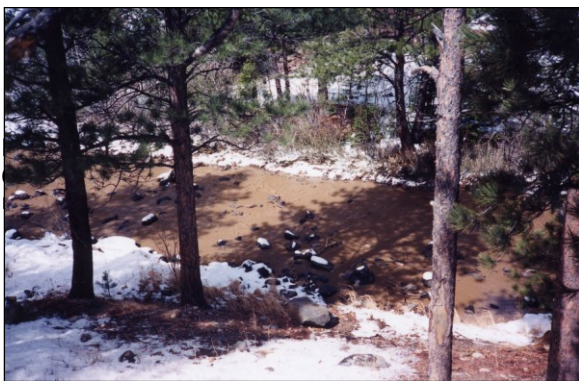
Figure 3. A rainstorm event over the Lefthand OHV Area resulting in sediment loading into Lefthand Creek.

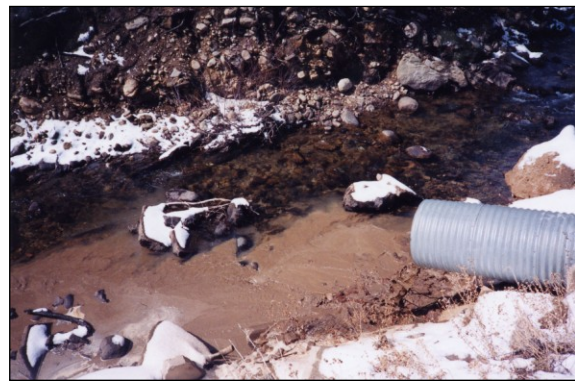
Figure 4. Nonpoint source pollution from the Lefthand OHV Area entering Lefthand Creek via a culvert under County Road 94.

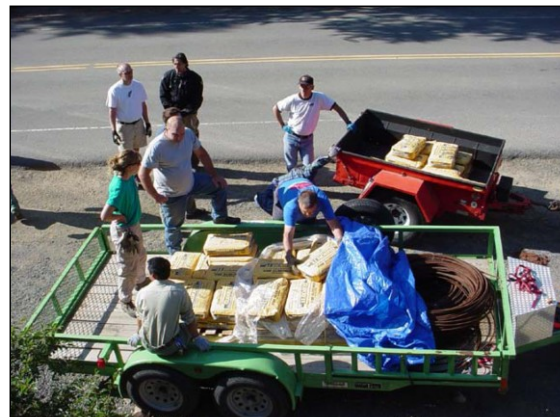
Figure 7. Trailridge Runners 4WD Club volunteers helped with hauling supplies up to the staging sites.

Products: The Restoration Team participated in project planning and field trips to the project sites (Fig. 6). Construction design plans were developed, restoration sites were prepared, and a schedule of work was completed prior to project implementation. Project and treatment areas were GPS mapped. Section lines and project areas were staked within the project corridor. Volunteers were recruited and trained prior to the 2009, 2010, and 2011 projects by Wildlands Restoration Volunteers. There were 389 volunteers who contributed 4,370 hours to Phase 2 projects. Tools and supplies were staged at central work zone sites (Fig. 7).

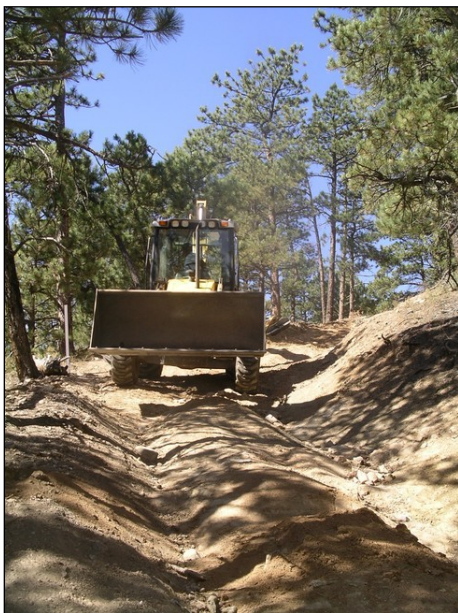
Figure 9. System route prior to regular road maintenance and grading by Budhoe Backhoe.

Products: During August 2009, water bars were placed along system routes, road/water crossings were repaired and stabilized using backhoe and boulders, and gullies were filled in. Regular road maintenance on the system routes was implemented to improve “travelability” and reduce resource damage. During the September 2010 Big Mother Hill Restoration Project, 12 water bars were constructed on the roadway to disconnect the disturbed areas of the road and to: 1) collect surface water runoff, 2) trap and settle sediment, 3) promote infiltration, 4) disperse energy, and 5) redirect runoff onto vegetated buffer areas. The implementation of this BMP resulted in a decrease of sediment movement into waterways. All Phase 2 backhoe work was completed by Budhoe Backhoe.

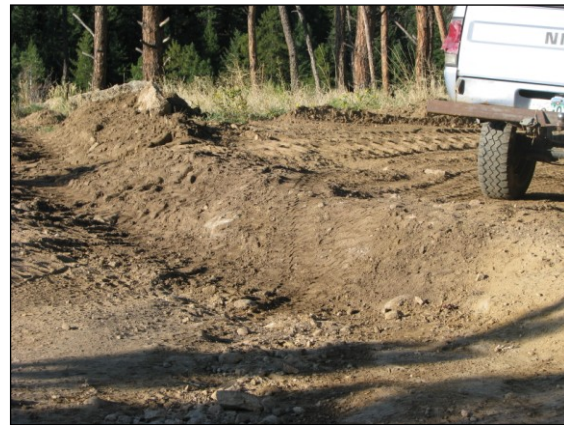
Figure 10. Water bars were constructed at locations on the roadway based on elevation and drainage need.

The construction of water bars along system routes within the project area were the most effective road BMP we used in the restoration project to decrease the nonpoint source sediment pollution from entering Lefthand Creek. The water bars disconnected the normal runoff pathways, decreased the volume and velocity of the runoff at any one site, thus decreasing the potential for sediment delivery and transport along the road. The drainage was dispersed onto vegetative buffers where sediment could be trapped and infiltration could occur.

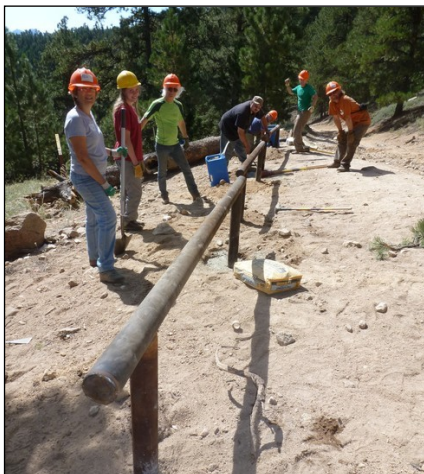
Figure 12. Volunteers constructing fencing.

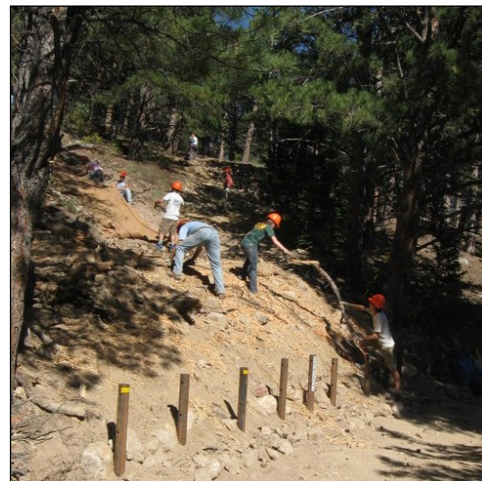
Figure 13. Volunteers restoring upland areas with erosion control matting, seed, and straw.

The use of mulching, native seed, erosion control matting, and planting shrubs on the obliterated roads and along the restored Carnage Canyon Creek were the most effective BMP we used to decrease soil loss and erosion. We observed the erosion control matting to be intact and over 90% of the vegetation thriving. The photo-log of the restoration sites included in this report documents the effectiveness of the treatments.

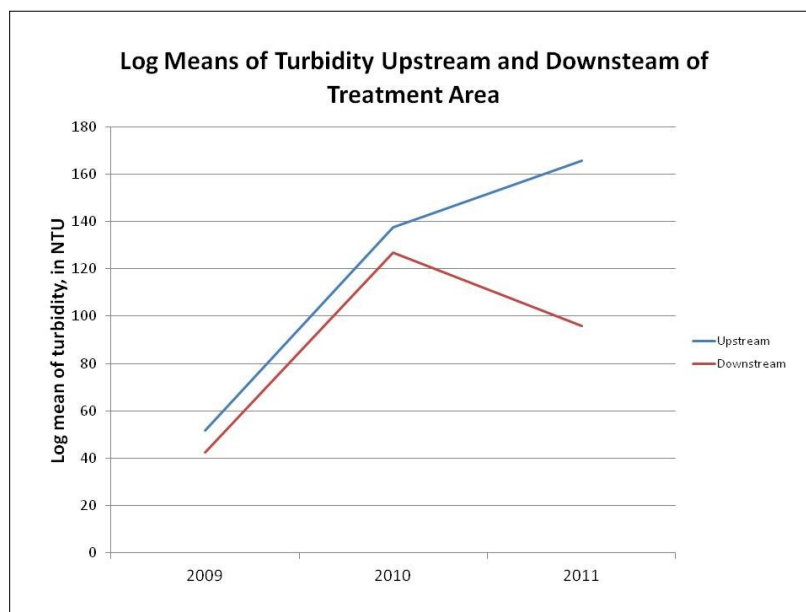
Turbidity records from all three summers will be addressed in this section. Since installation of sediment control measures was not complete until the 2011 season, emphasis will be placed on records from 2011. When considering turbidity records covering the whole season, it is advisable to use log-mean values of the data, to account for the large variation observed in turbidity values. Shorter records, covering a few days, may be analyzed with regular arithmetic mean values. Looking at the entire turbidity record for the three seasons, the annual log-mean turbidity values for the upstream station were consistently higher than the log-mean turbidity values for the downstream station (Fig. 15).

Figure 15. Annual log means of turbidity upstream and downstream of treatment area, 2009-11

This pattern indicates that the flow from Carnage Creek tended to dilute, rather than add to, the concentration of suspended sediment in Left Hand Creek. This would be an indication that the installed sediment control measures were effectively reducing concentrations of suspended sediment in Carnage Creek. Prior to installation of these sediment control measures, Carnage Creek tended to add to, rather than dilute, the suspended sediment concentrations in Left Hand Creek, owing to the mobilization of sediment by vehicular traffic on steep slopes unprotected by vegetation.

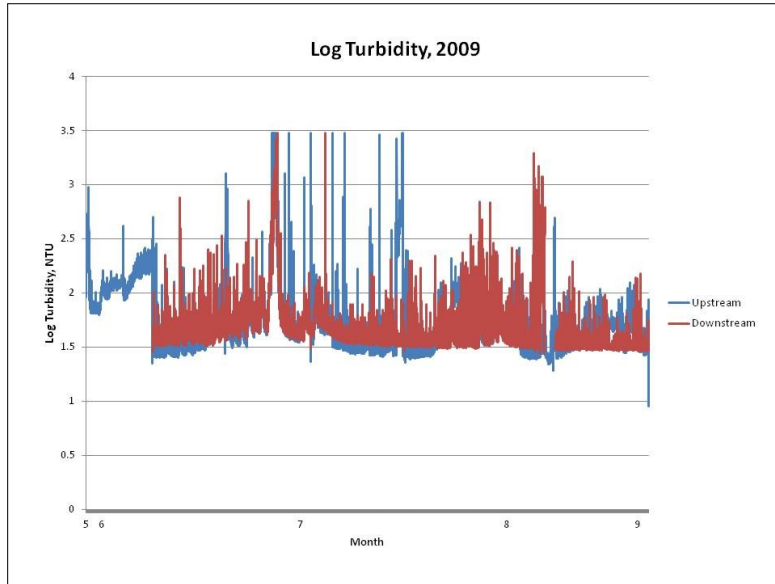
Logs of 5-minute turbidity values for 2009 are presented in Fig. 16. This graph demonstrates the typical variability inherent in the turbidity record. In general, turbidity values are similar for the upstream and downstream stations, but there are more times when the upstream value was greater than the downstream value, than vice-versa.

Figure 16. Logs of 5-minute turbidity values for summer 2009.

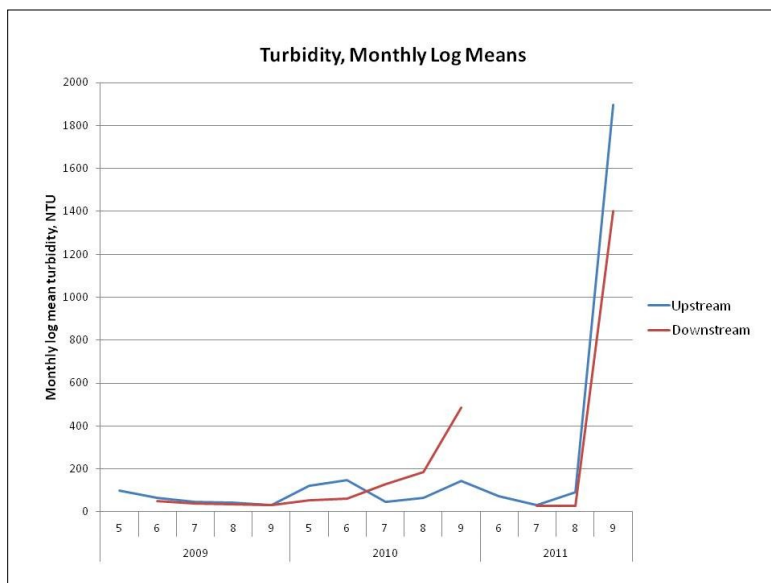
Looking at the log-mean turbidity trends by month for all three years (Fig. 17), it can be seen that in 2009 the upstream and downstream values were relatively low and similar to each other, with the downstream values being slightly lower than the upstream values. In 2010, there was slightly more variability in the data, and in some months the downstream station had higher log-mean turbidity values than the upstream station. In 2011, when installation of the sediment control measures was complete, the downstream station had consistently lower log mean values than the upstream station, even during the storms and high flows that brought high turbidity values to both stations late in the season.

Figure 17. Monthly log mean turbidity values, 2009-11.

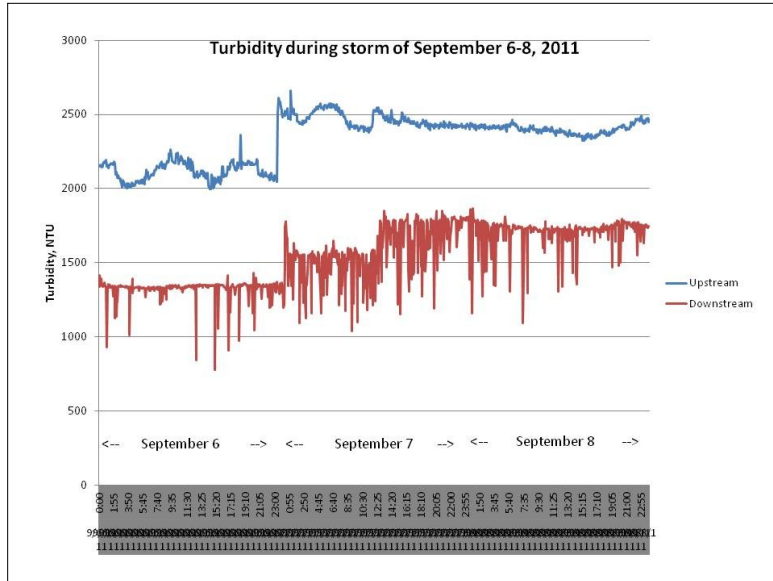
A typical period of record influenced by a rainstorm and high flows is presented in Fig. 18. This graph shows 5-minute turbidity values for the period September 6-8, 2011. During this time the sediment control measures were in place, and a significant rainstorm, widespread over the area, brought high flows to the creek. Rainfall totals at the Fairview precipitation gage were 0.54 inches on September 6 and 0.95 inches on September 7. Volunteer precipitation monitoring stations in the mountainous part of Boulder County registered in the range of 0.7 inches on September 7 and 0.3 inches on September 8.

Figure 18. 5-minute turbidity values during the storm of September 6-8, 2011.

During this storm, turbidity values were elevated at both stations, but the upstream station had consistently higher values than the downstream station.
