DTC	B0130/63	Short in P/T Squib (RH) Circuit
------------	-----------------	--

CIRCUIT DESCRIPTION

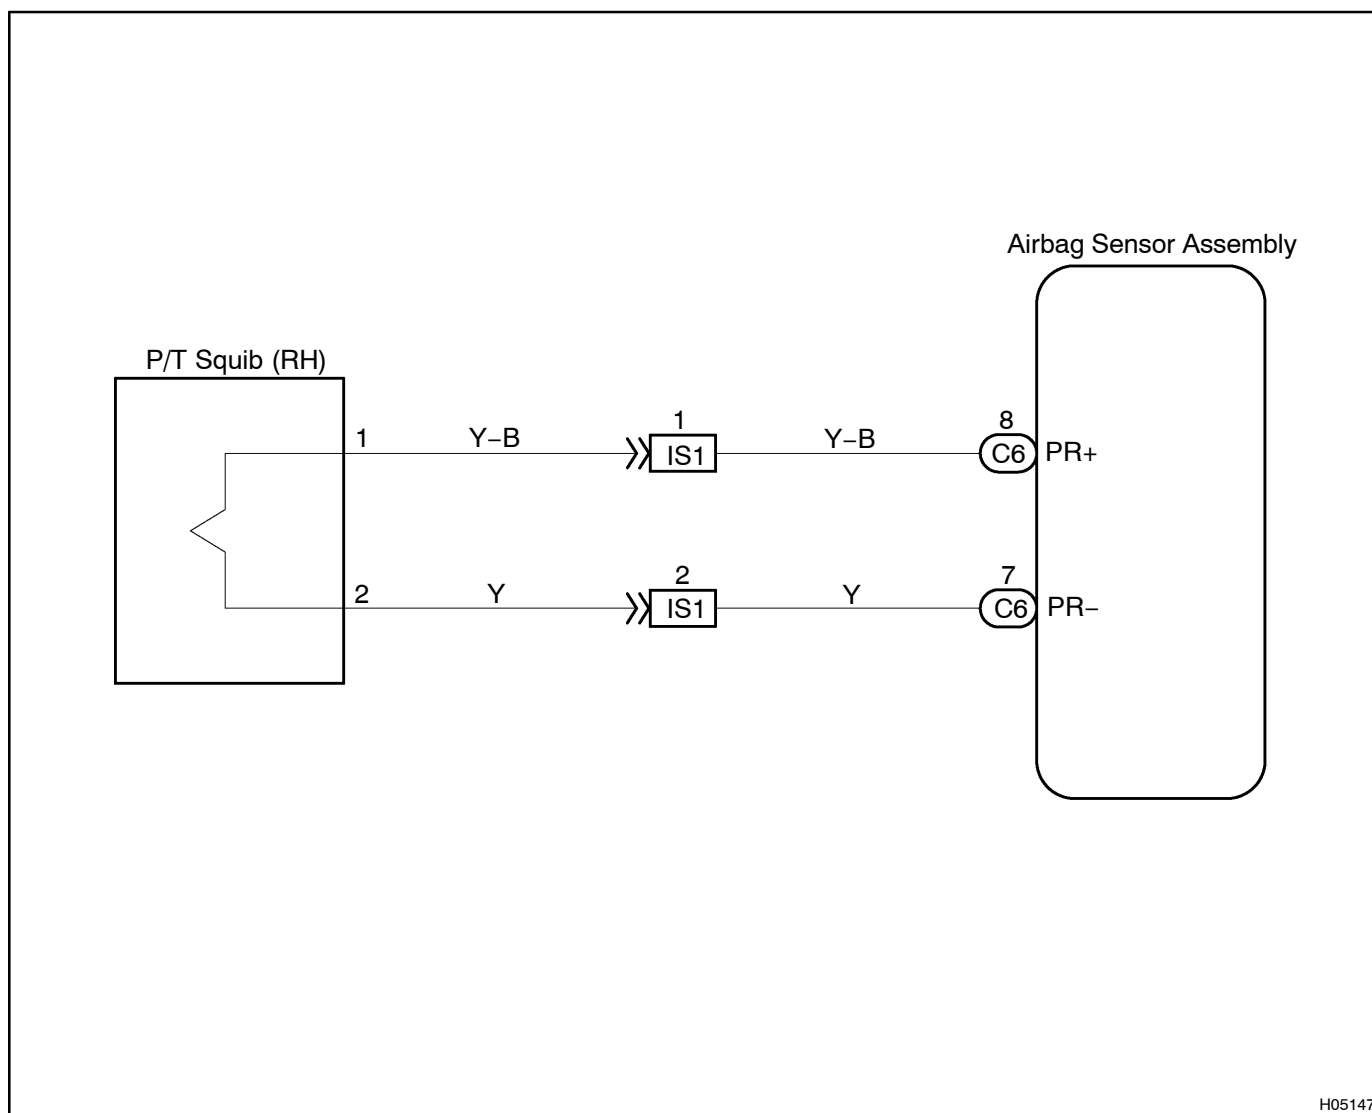
H05147

The P/T squib (RH) circuit consists of the airbag sensor assembly and seat belt pretensioner (RH). It causes the seat belt pretensioner (RH) to activate when the seat belt pretensioner (RH) activation conditions are satisfied.

WIRING DIAGRAM

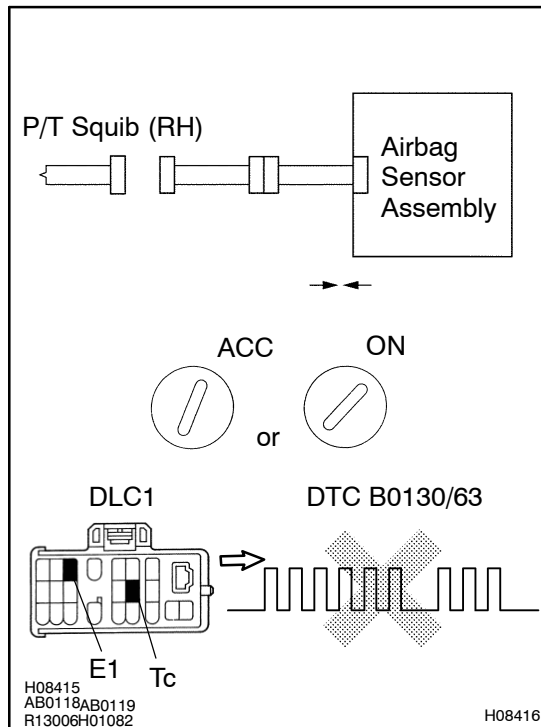
3 Check airbag sensor assembly.

- Connect the connector to the airbag sensor assembly.
- Connect negative (-) terminal cable to the battery, and wait at least for 2 seconds.

- Turn ignition switch to ACC or ON and wait at least for 20 seconds.
- Clear DTC stored in memory.
(See page [DI-449](#))
- Turn ignition switch to LOCK, and wait at least for 20 seconds.
- Turn ignition switch to ACC or ON, and wait at least for 20 seconds.
- Check DTC.
(See page [DI-449](#))

DTC B0130/63 is not output.

Replace airbag sensor assembly.

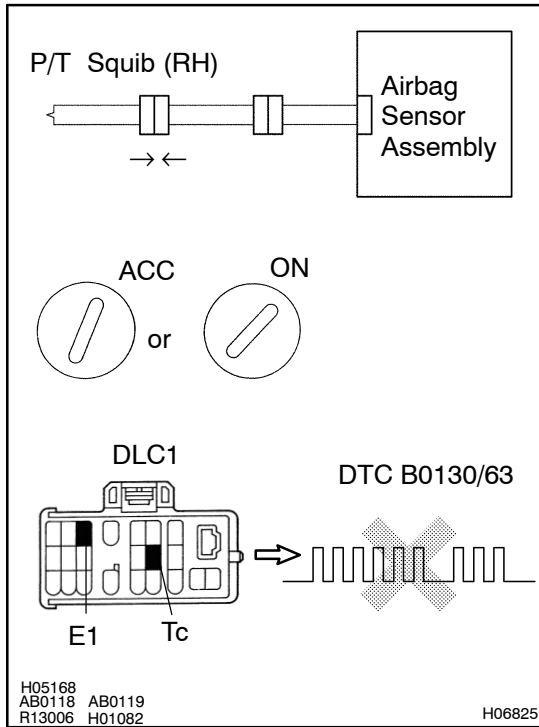
4 Check P/T squib (RH).

- Turn ignition switch to LOCK.
- Disconnect negative (-) terminal cable from the battery, and wait at least for 90 seconds.
- Connect the seat belt pretensioner (RH) connector.
- Connect negative (-) terminal cable to the battery, and wait at least for 2 seconds.

- Turn ignition switch to LOCK, and wait at least for 20 seconds.
- Turn ignition switch to ACC or ON, and wait at least for 20 seconds.
- Clear DTC stored in memory.
(See page [DI-449](#))
- Turn ignition switch to LOCK, and wait at least for 20 seconds.
- Turn ignition switch to ACC or ON, and wait at least for 20 seconds.
- Check DTC.
(See page [DI-449](#))

DTC B0130/63 is not output.

Replace seat belt pretensioner (RH).
